Manhole Inspection Summary

Manhole # S33EE_014MH

Location Address: **1114 MORTON ST**

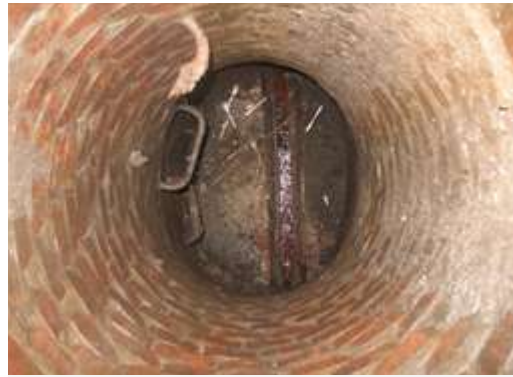
Top View

Corroded and missing steps. Bench debris.

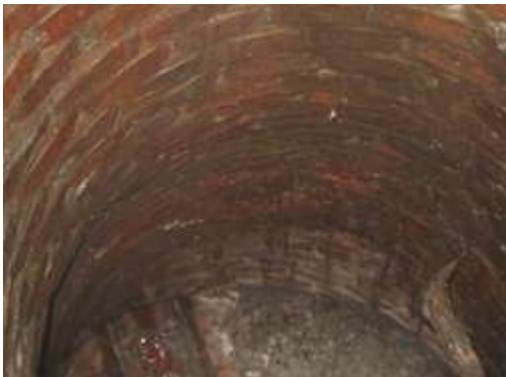
Defect

Corbel and Barrel infiltration.

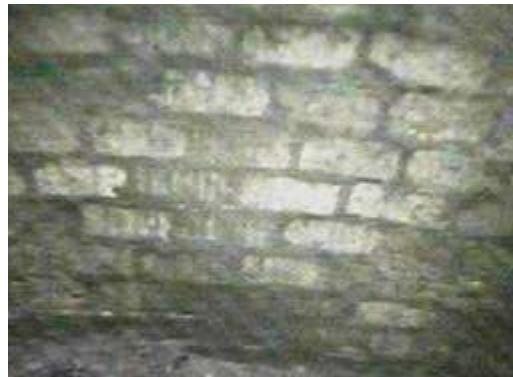
Defect

Barrel infiltration.

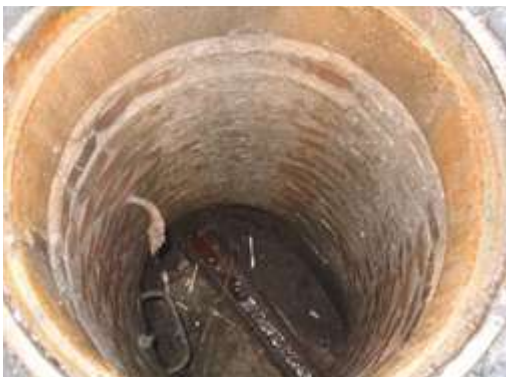
Defect

Frame leaks. Adjustment deterioration and infiltration.

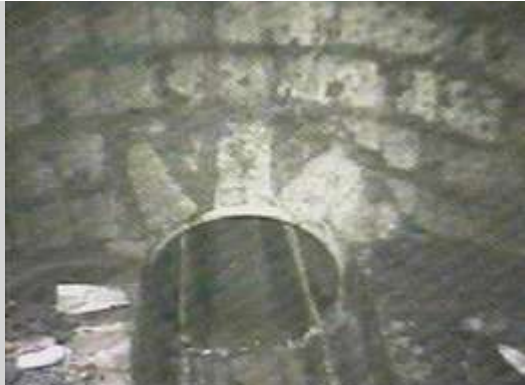
8 in. Circular Gravity Sewer Pipe Out @ 12 O'Clock

Deposits: ☐ None ☐ Mud ☐ Sludge ☐ Debris ☒ **Grease**

Silt Depth: **0** (in.) Deposits Extent: **Light**

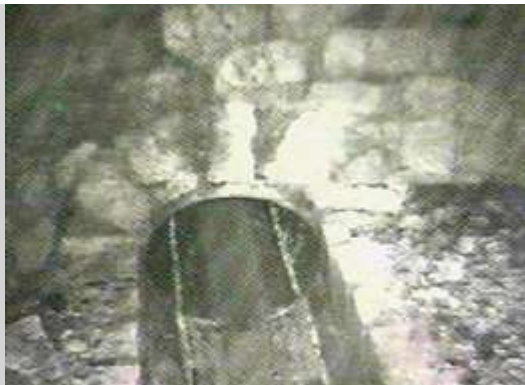
8 in. Circular Gravity Sewer Pipe In @ 6 O'Clock

Deposits: ☐ None ☐ Mud ☐ Sludge ☐ Debris ☒ **Grease**

Silt Depth: **0** (in.) Deposits Extent: **Light**
